Comparison of X-ray Computer Tomography and Magnetic Resonance Imaging for Detection of Pest Infestation in Prunus Persica

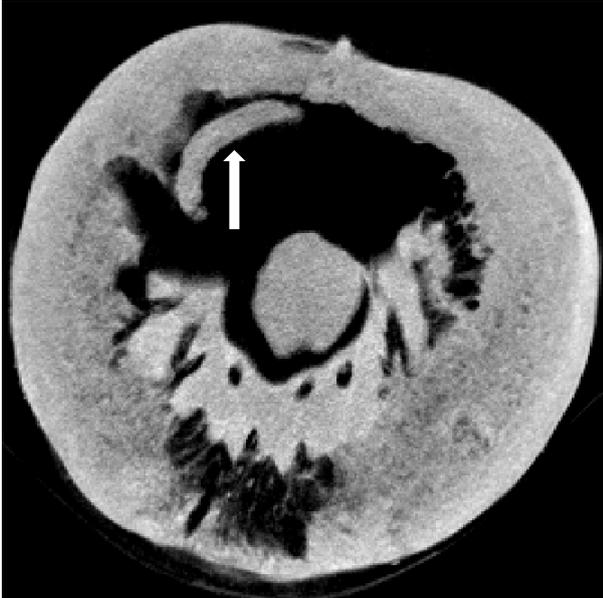
(v1.53a National Institutes of Health, USA) [5]. Fig. 1 shows the *Prunus persica* X-ray CT image. The internal structure of *Prunus persica* damaged by pests was confirmed through an X-ray CT image. The difference between the sound flesh part and the part damaged by pests was distinguished. However, the contrast between *Tenebrio Molitor*'s larva and *Prunus persica*'s flesh was not clear.

Fig. 1. *Prunus persica* X-ray CT image. The white arrow indicates a *Tenebrio Molitor* larva.

The contrast is insufficient to check whether or not pests have infested into the fruit at the actual quarantine site. To perform more efficient NDT inspection using X-ray CT, it seems necessary to optimize scan parameters and improve detector performance. In this study, the CT component in the PET/CT, which has lower performance than general X-ray CT, was used. If micro CT is used in the future, better inspection results would be obtained.

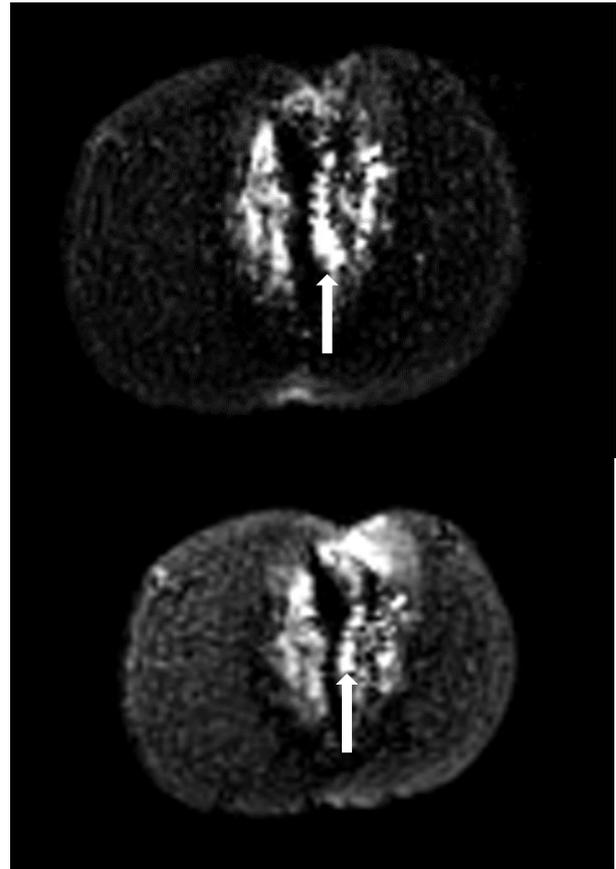
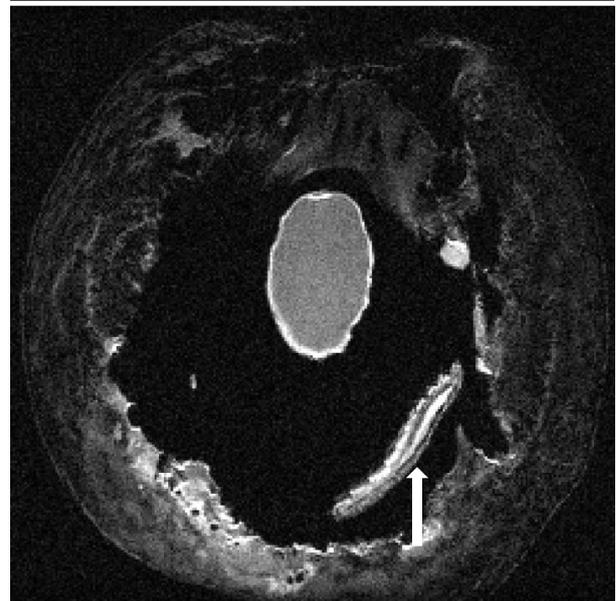
Fig. 2 shows the *Prunus persica* MRI images. Similar to the X-ray CT image, the internal structure of *Prunus persica* damaged by pests was confirmed through MRI images. MRI images were acquired with various magnetic field strengths, and the difference in image quality was clearly distinguished according to the magnetic field strength.

Fig. 2. *Prunus persica* MRI images. 3.0, 7.0, and 9.4 T T₁-weighted MRI images from top to bottom. The white arrows indicate a *Tenebrio Molitor* larva.

Naturally, the stronger the magnetic field strength, the better the contrast. However, in the case of MRI, the equipment is very expensive and takes a long time to shoot, so it is not suitable for use in the actual quarantine site. In other words, actual quarantine NDT inspection using X-ray CT is more realistic, and MRI will be a method for more detailed NDT inspection.
